HYDRAULIC TAPPETS

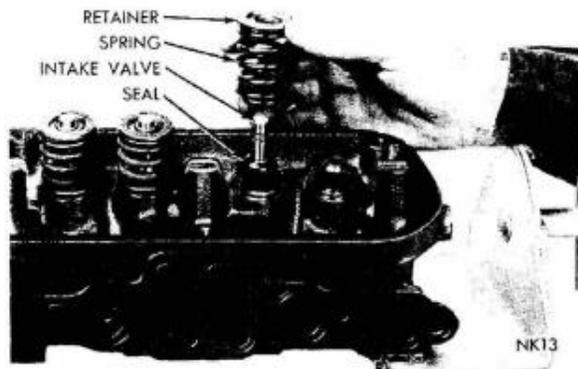
Fig. 19—Installing Valve, Cup Seals, Spring and Retainer

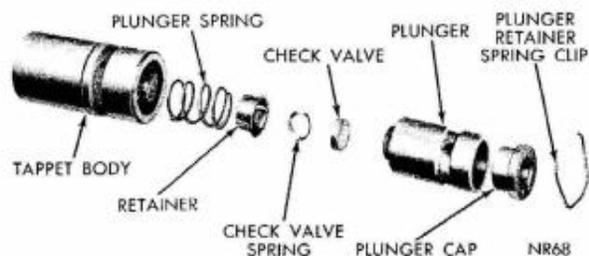
Fig. 20—Hydraulic Tappet Assembly (Disassembled View)

CAUTION: The plunger and tappet bodies are not interchangeable. The plunger and valve must always be fitted to the original body. It is advisable to work on one tappet at a time to avoid mixing of parts. Mixed parts are not compatible. Do not disassemble a tappet on a dirty work bench.

Disassembly (Fig. 20)

(1) Pry out plunger retainer spring clip.

(2) Clean varnish deposits from inside of tappet body above plunger cap.
